Case History

Analysis of generator rotor unbalance

by *George Murray and John Mucci*
Consolidated Edison
and *Scott Brier*
Sales Engineer
Bently Nevada Corporation

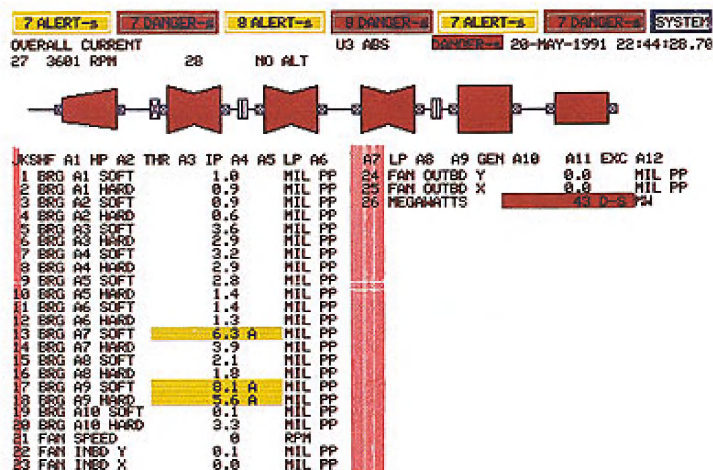
Figure 2
High vibration levels on Bearings No. 7 & 9 detected on System 64
Current Overall Values screen

On May 20, 1991, shortly after Unit No. 3 returned to service, the vibration monitor's alarm status went into a "Danger" condition. The overall vibration levels shown in Figure 2, indicate that Bearing No. 9 was experiencing high vibration. When they viewed the synchronous or 1X frequency component (Figure 3), operators noticed that this was the major contributor to the overall vibration. They decided to install an unbalance correction weight (balance shot) in the generator rotor as an attempt to reduce its 1X vibration.

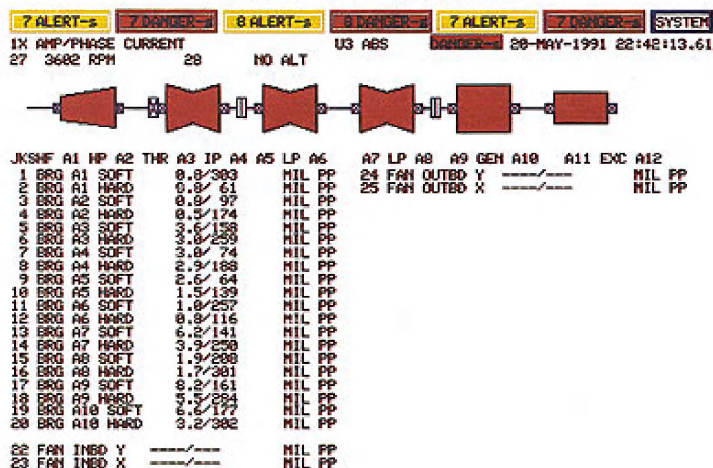
Figure 3
System 64 Amplitude versus Phase screen

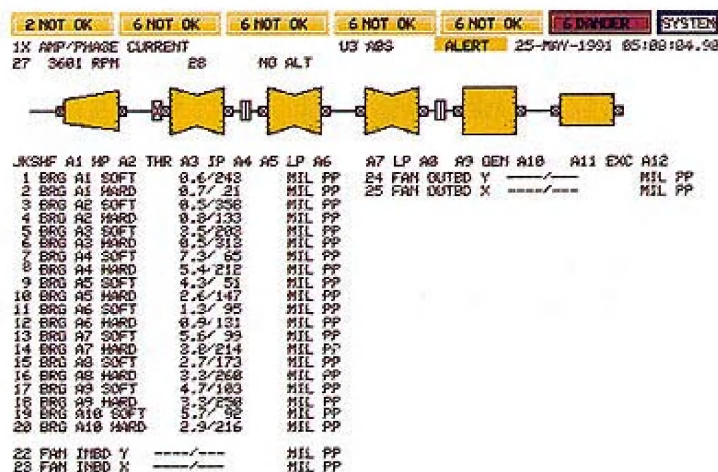
A balance shot was calculated, and correction weights were installed in the generator rotor on May 23. Figure 4 shows that, while the balance move brought Bearing No. 9's 1X vibration below the alarm levels, Bearing No. 10 was now in an Alert condition. Another balance shot, to trim the vibration down to a more acceptable level, was installed on May 26. This balance shot behaved as expected, and all parties felt that further balancing would have a beneficial effect on the unit's overall vibration levels.

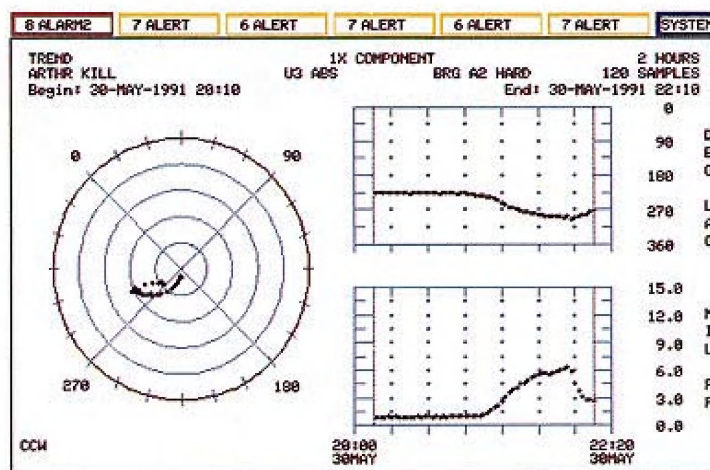
Figure 5

Figures 5 and 6 are 1X Amplitude/Phase Trend plots for the turbine and generator, respectively. From these figures, it was concluded that the generator Bearing No. 10 (Figure 6) was responding to a turbine steam seal rub (Figure 5) and not rotor unbalance. These plots show how the 1X vector "walked out," reversed direction, and then returned to its original position. This is an example of how a steam seal rub initiates and finally rubs itself out.

1X Amplitude/Phase Trend plot of the turbine

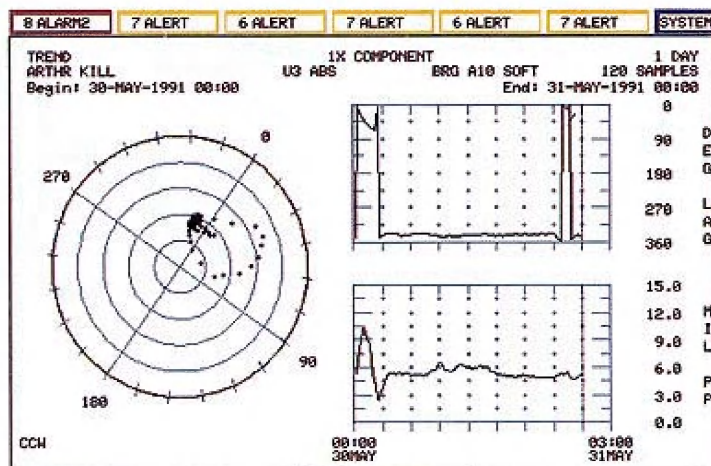
Figure 6

1X Amplitude/Phase Trend plot of the generator

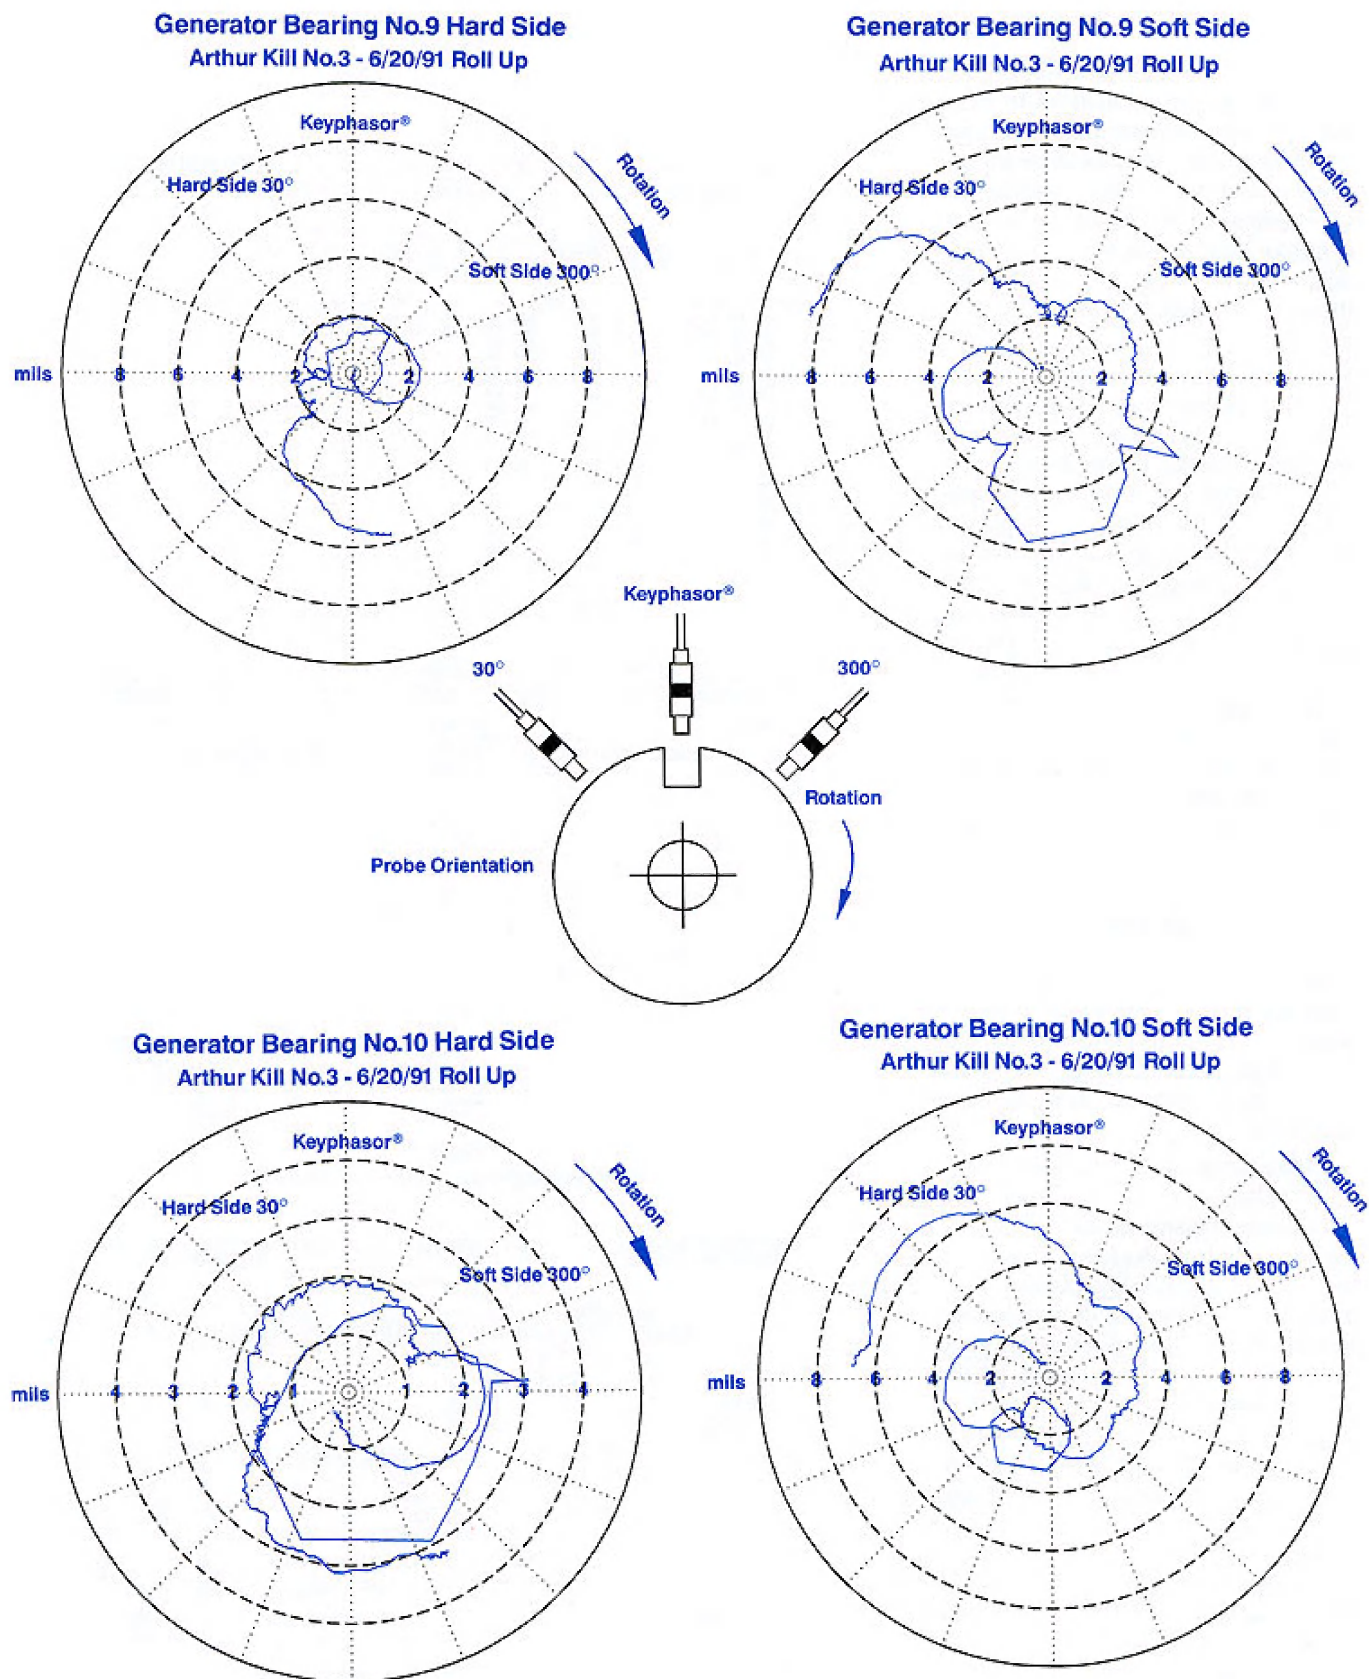
Because the generator was operating close to its third balance resonance speed (Figure 7), any additional excitation, even down at Bearing No. 2, would result in an amplified response. That is why Bearing No. 10 had a greater

response to the rub than Bearing No. 2.

Figure 7
Polar plots of Machine Startup. Note: Third party software was used.

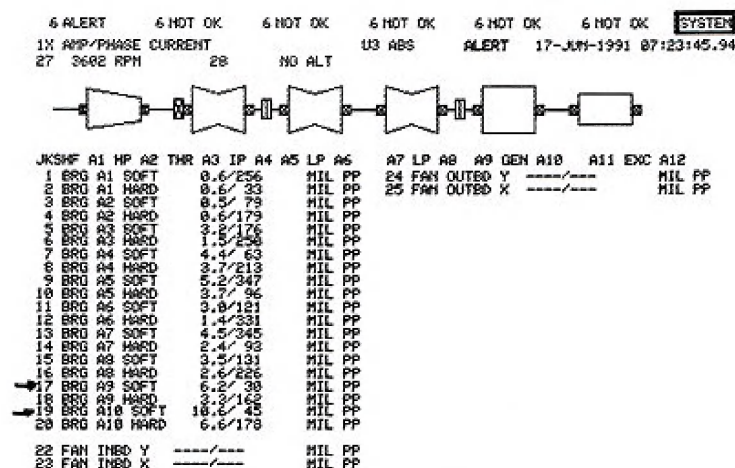
Figure 8

After working out the rub, the unit operated relatively trouble-free. On June 17, an overspeed trip test was scheduled for Unit No. 3. Because the generator rotor had responded favorably to previous balancing attempts, another balance shot was attempted by placing the correction weight in the alterex-to-generator coupling at a radius of 8 inches (203 mm). For a relatively small correction weight (5 ounces or 142 grams) at the alterex coupling, the results were totally unexpected. Generator vibration increased to levels that were not consistent with either the correction weight mass or previous responses (Figure 8).

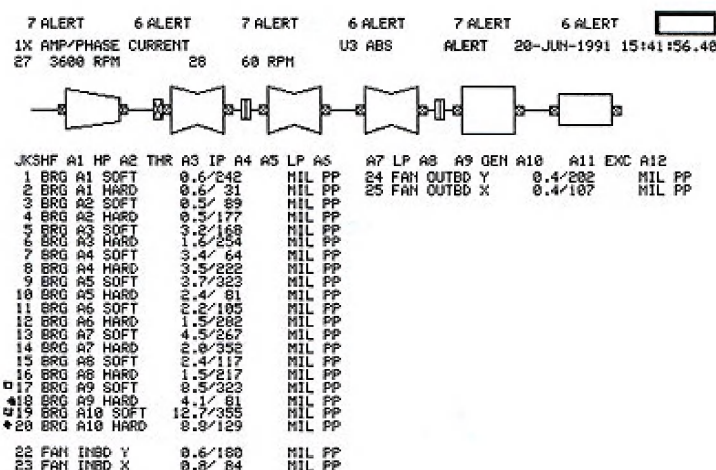
Figure 9

This immediately alerted the station's operating personnel to a potential problem with the generator. However, it was decided to attempt another balance shot on June 20 to verify the inconsistent results. The results once again were inconsistent with the expected response (Figure 9). The decision to continue balancing was aided by having the unit's operating conditions continuously monitored.

At this point, it was necessary to look at the balance sensitivities derived from the previous balance moves. The sensitivity derived from the first balance shot was 5.8 ounces/mil (6.4 grams/ μ m) at 155 degrees. This was not considered unusual for this type of rotor. After the five ounce (142 gram) change to the alterex coupling, the sensitivity had changed to 1.2 ounces/mil (1.33 grams/ μ m) at 105 degrees. It would seem almost impossible for a five ounce weight to have an effect of this magnitude on a sixty-two ton (56,246 kg) rotor. This inconsistency was also confirmed by the June 20 balance shot which resulted in a sensitivity of 2.0 ounce/mil (2.2 grams/ μ m) at 123 degrees.

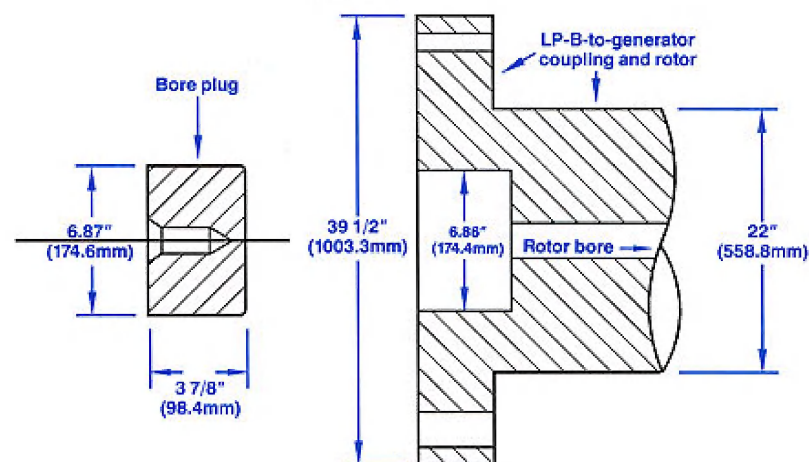
On September 23, 1991, the Low Pressure-to-Generator coupling was disassembled and parted. As predicted, the Low Pressure rotor's bore plug was found in the coupling spacer gear's bore. Figure 10 shows how the bore plug fits into the coupling bore.

Diagram showing how the bore plug fits into the coupling bore

The information from System 64 was critical in arriving at a correct diagnosis of this problem. When the bore plug was reinstalled, vibration levels returned to acceptable levels. This case history documents the importance of computerized monitoring systems used in conjunction with a traditional monitoring system. ■
